MM912_634, Silicon Analog Mask (M91W) / Digital Mask (N53A) Errata

This errata document applies to the [MM912_634](#) product family.

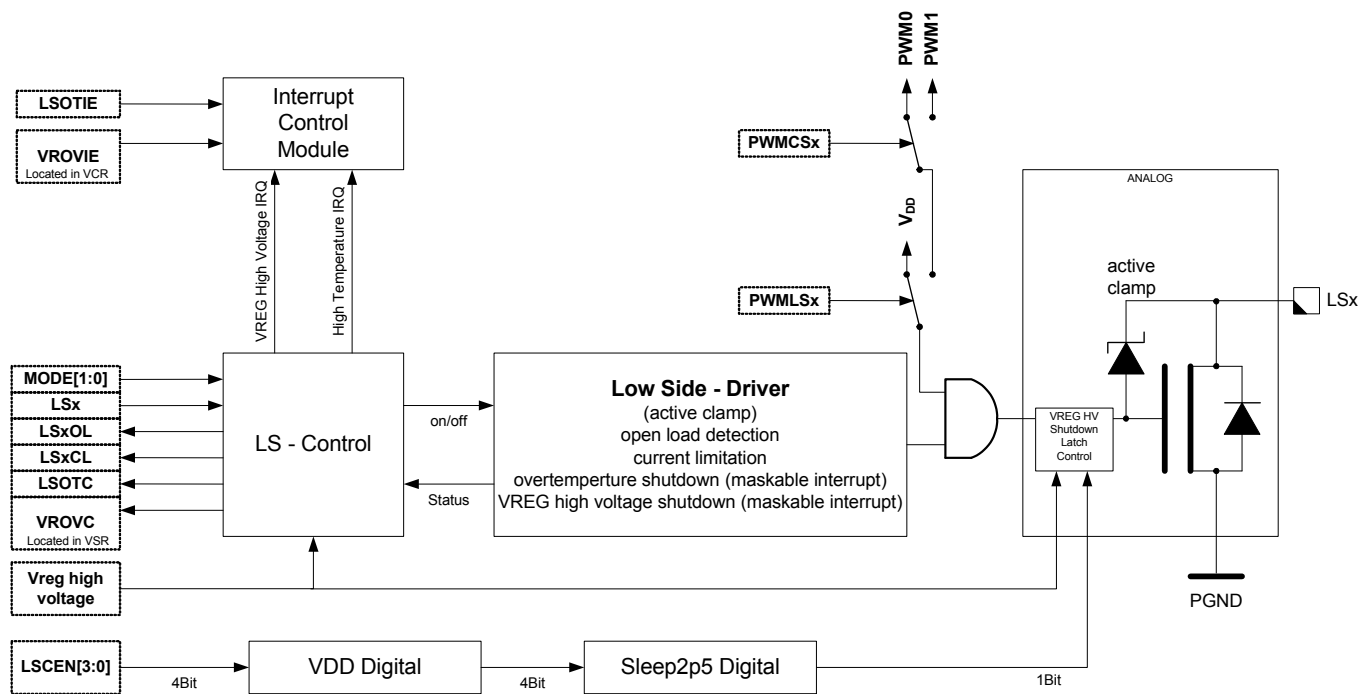
Figure 1. Low-side Block Diagram

The Low-side Control Enable (LSCEN) register is reset only after LVR, LVRX and POR. It does not reset in case of an VREG Over-voltage event. See Figure 1. Low-side Block Diagram.

A digital implementation issue prevents the LSCEN register from resetting when a VREG high voltage condition occurs. The intent of the LSCEN register is to create a secondary deactivation stage for the low-side drivers, thereby verifying that the VDD-Digital and the Sleep2p5 Digital circuitry is functional after the occurrence of a VREG high voltage condition.

The Low-side Control Enable (LSCEN) register does not reset after a VREG Over-voltage event.

To maintain compatibility with a potential future silicon fix, Freescale recommends using the register write LSCEN=0x5 to re-enable the low-side.

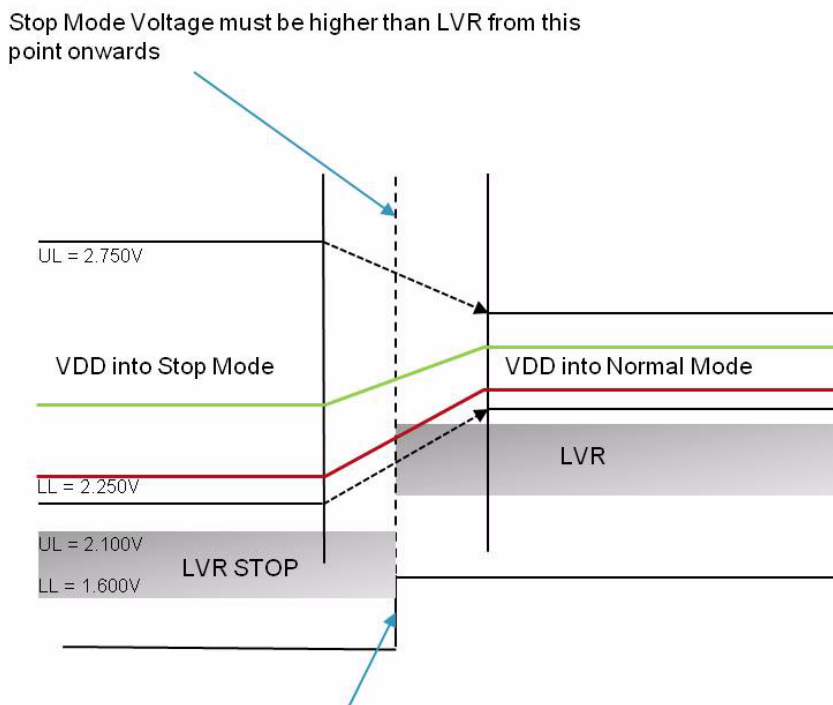
Figure 2. Stop mode to Normal mode Transition

After a transition from Stop mode to Normal mode due to a wake-up event, the device may generate a Reset. If this occurs, the WUR bit in the RSR register is set until a reading of RSR register occurs. This behavior will affect parts with VDD in Stop mode below LVR in Normal mode.

When a wake-up event occurs, the transition from stop mode to normal mode begins. The VDD stop regulator switches to VDD normal regulator. The LVR normal mode is activated. If the actual VDD regulator output voltage is below LVR normal, the device generates a reset on the RESETA pin.

In **Figure 2**, the green line denotes a part that does not show this behavior. The red lines denotes a part that does show this behavior. The VDD parameter in Stop mode is distributed between 2.25 V and 2.75 V, while the LVR Normal is max 2.40 V. Only devices that have an actual VDD stop between 2.25 V and 2.40 V will exhibit this behavior.

The software recommendation to help minimize the impact of the behavior consists of verifying the Reset source after a wake-up. This check might be performed after a return from the reset sequence. If a reset occurs, the following flag is as described below:
